FOURTH ENDORSEMENT on VP-24 AAR ser 2-52 of 21 Oct 1952

Subj: Aircraft Accident Report P4Y-2B BuNo. 59988

THIRD ENDORSEMENT on VP-24 Aircraft Accident Report serial 2-52

SECOND ENDORSEMENT on VP-24 Aircraft Accident Report serial 2-52

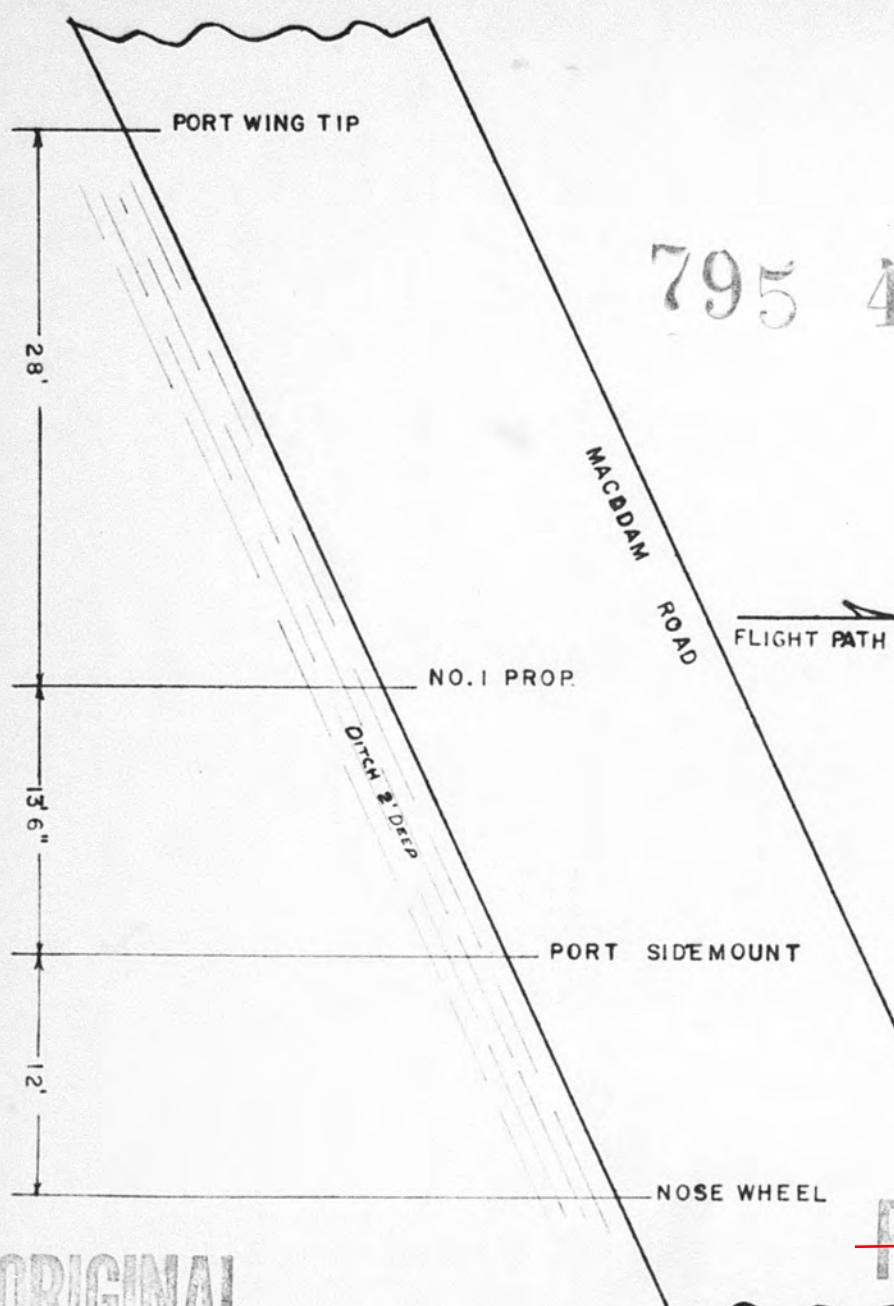
Enclosure (22)

- (30.) The first damage to the aircraft occurred at the initial point of impact 548 feet short of runway 25, Enclosures (15) and (22). At this point the port wing hit the surface of the elevated road followed almost immediately by the propellor of the number one engine, Enclosure (20). The port main gear struck the ground 15 feet short of the elevated road and continued into the side of the road bed, Enclosure (21). The impact at an estimated speed of 125 knots and an angle of approximately 5 degrees produced unknown damage to the port wing tip and bending the propellor blades causing the propellor and nose section of number one engine to shear off. The propellor struck the ground 130 feet from the impact point and came to rest 65 feet from the approach end of runway 25, Enclosures (23) and (24). After hitting the roadbed the port main gear oleo was sheared spraying hydraulic fluid across the road, Enclosures (25) and (26), and the broken main gear piston dropped out shortly thereafter, Enclosure (27). The port main gear hanging by the drag strut broke loose and came to rest as indicated in Enclosures (28), (29), and (30) after bouncing down the runway, Enclosure (31) (32). A portion of the port landing flap, Enclosure (33), was torn off by the port main gear when it broke loose and came to rest about 250 feet from the end of the runway, Enclosure (16). The port wing tip again struck the ground about 200 feet from the end of the runway and dragged along the ground striking the outboard starboard threshold light, Enclosure (34). The plane continued in an arc across the runway in an increasing bank to the 1 ft dragging the port wing tip, Enclosure (16). At the time the plane left the runway, 430 feet from the beginning, along the port edge, it was in a vertical bank missing a high intensity light by 3 $\frac{1}{2}$ feet, Enclosure (35) and (36). The aircraft became inverted and collided nose first with the ground 150 feet from the port edge of runway 25, Enclosure (37). At this position the engines were thrown from their mounts directly ahead of the aircraft. Plexiglass from the bow turret dome, Enclosure (38), and the positions of the engines indicate that the aircraft was inverted upon colliding with the ground, Enclosure (17). The airspeed is estimated at 110 knots and the angle of impact at 45 degrees. The momentum at this impact then caused the aircraft to fall over on the ventral side righting itself again striking the ground but with the fore and axis now approximately 130 degrees to its former path of travel, Enclosure (17). From this position the entire aircraft slid sideways separating in three sections; the flight deck, the wing section, and the tail section, Enclosures (18) and (40). The flight deck section came to rest approximately 135 feet from the second major impact position and 130 degrees to the path of travel, Enclosures (41), (42), and (43).

CONTACTS MADE BY VARIOUS PARTS OF PLANE AT INITIAL IMPACT ALONG ROAD.
